Manhole Inspection Summary

Manhole # S29YY1019MH

Location Address: **5200 CHARLES ST**

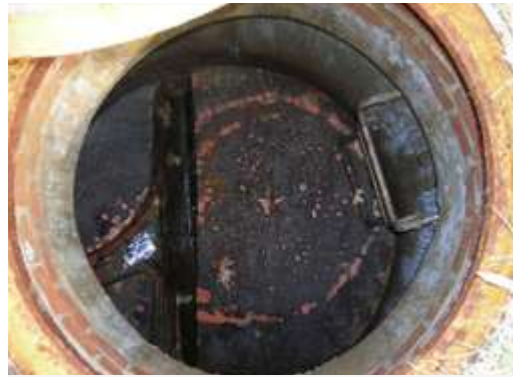
Top View

Evidence of surcharge - Bench debris.

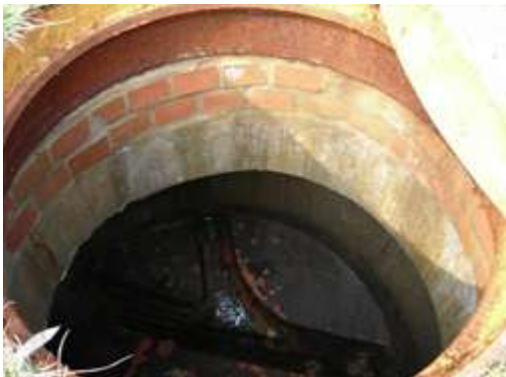
Defect

Adjustment and Corbel infiltration.

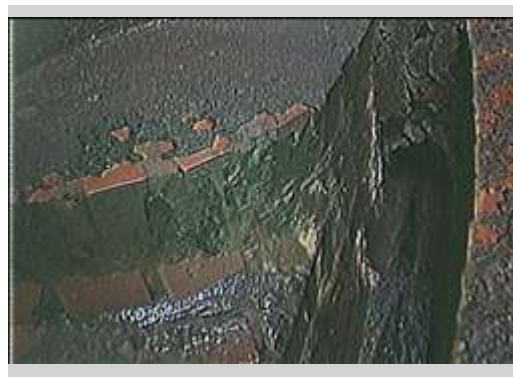
Defect

Channel deterioration.

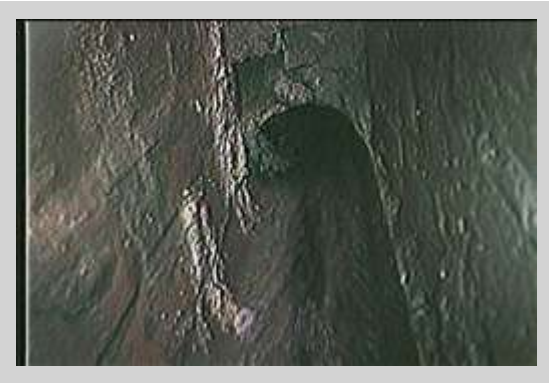
6 in. Circular Gravity Sewer Pipe Out @ 12 O'Clock

Infiltration: **Evidence** Pipe Seal Cond: **Broken**

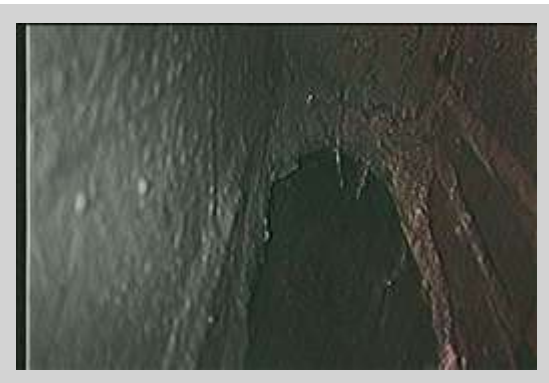
6 in. Circular Gravity Sewer Pipe In @ 6 O'Clock

Infiltration: **None** Pipe Seal Cond: **Broken**

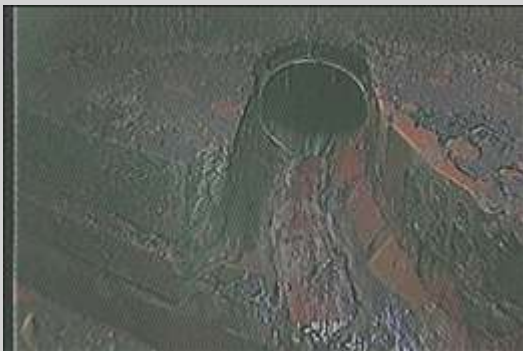
6 in. Circular Gravity Sewer
Pipe In @ 8 O'Clock

Channel deterioration.

Infiltration: **Evidence** Pipe Seal Cond: **Unknown**
